Subject: Department of Natural Resources Washington Geological Survey,  
School Seismic Safety Assessments Project Phase 2, Contract No. AE 430 -  
Seismic Evaluation for **Spokane**

## **School Buildings Evaluated in the Spokane School District**

1. Bancroft (The Community School), Main Building
2. Bryant Center, Main Building
3. Havermale (Montessori), Main Building 1928 and 1940 Areas
4. Havermale (Montessori), Main Building 1928 Gym
5. Havermale (Montessori), Main Building 1965 Areas
6. Madison Elementary School, Main Building

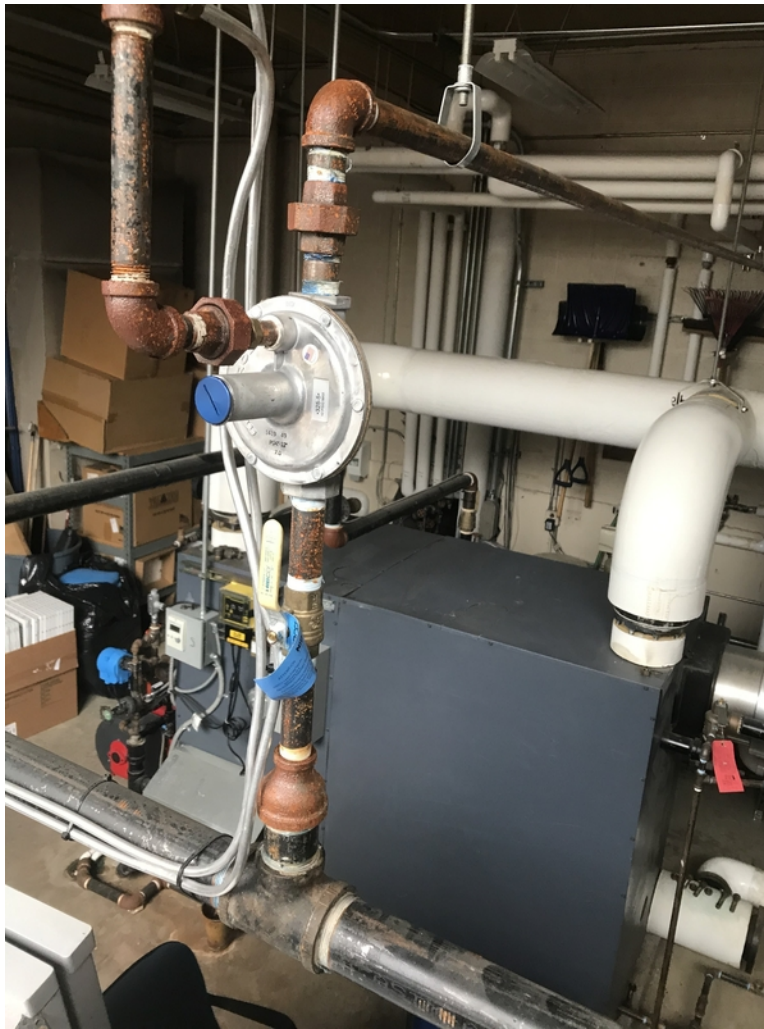
Figure 1-1. Mechanical room; some bracing observed on the elevated pipes.

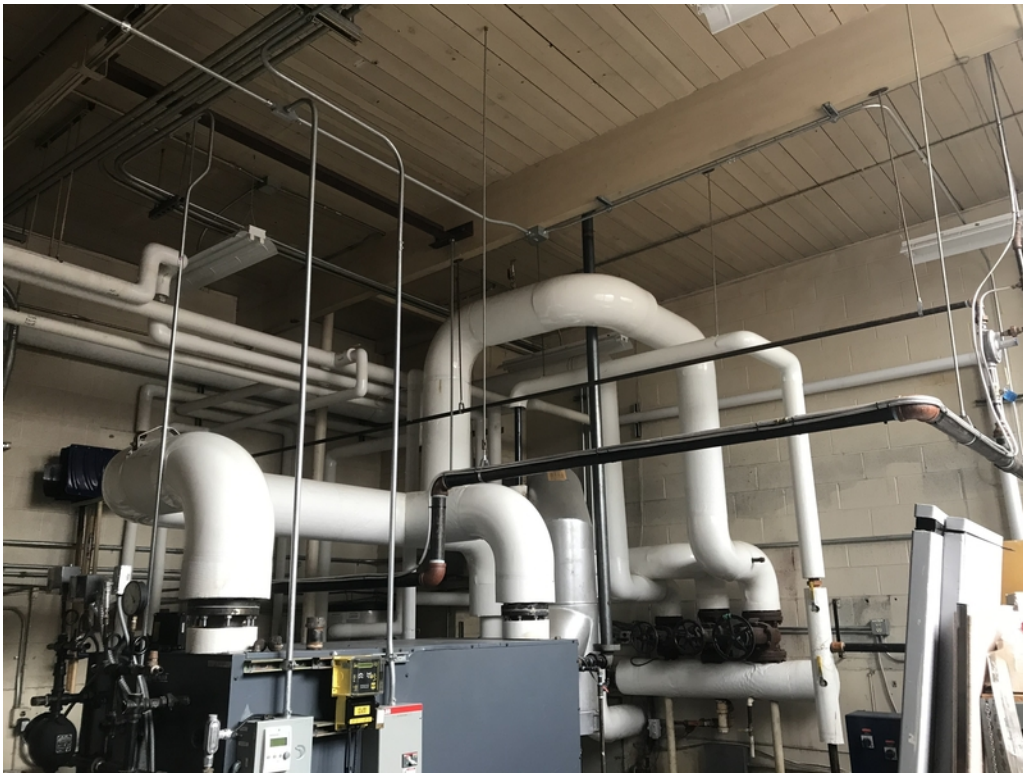
**Figure 1-2. Mechanical room.**

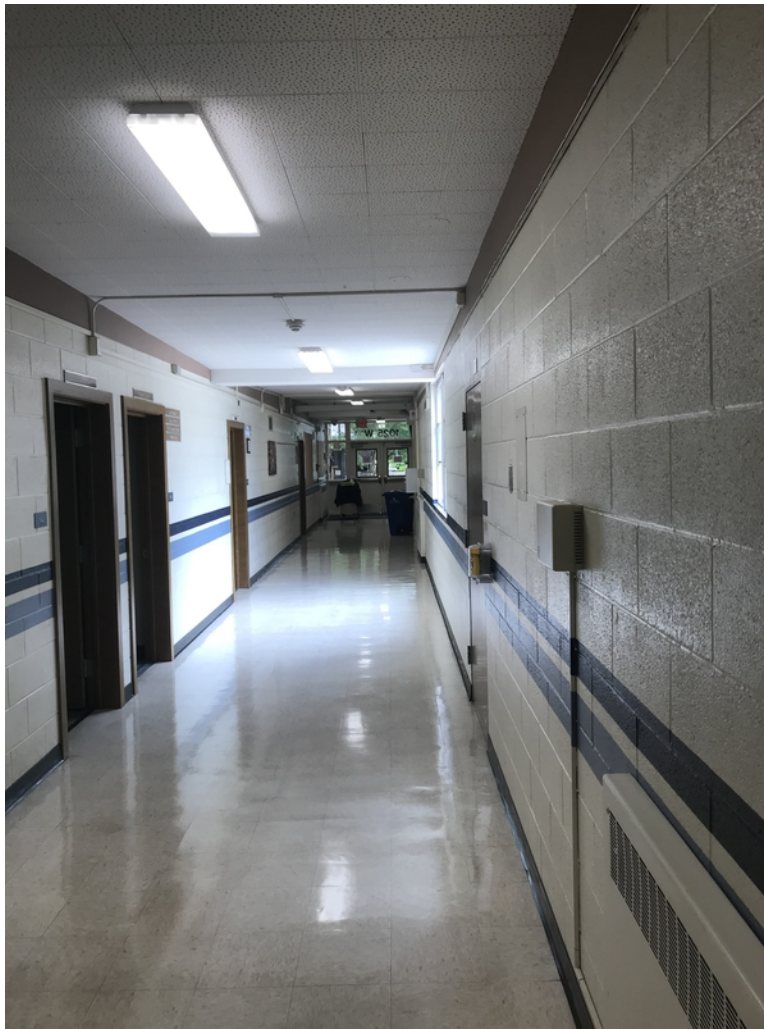
**Figure 1-4. Hallway with masonry walls; wood framing observed above.**

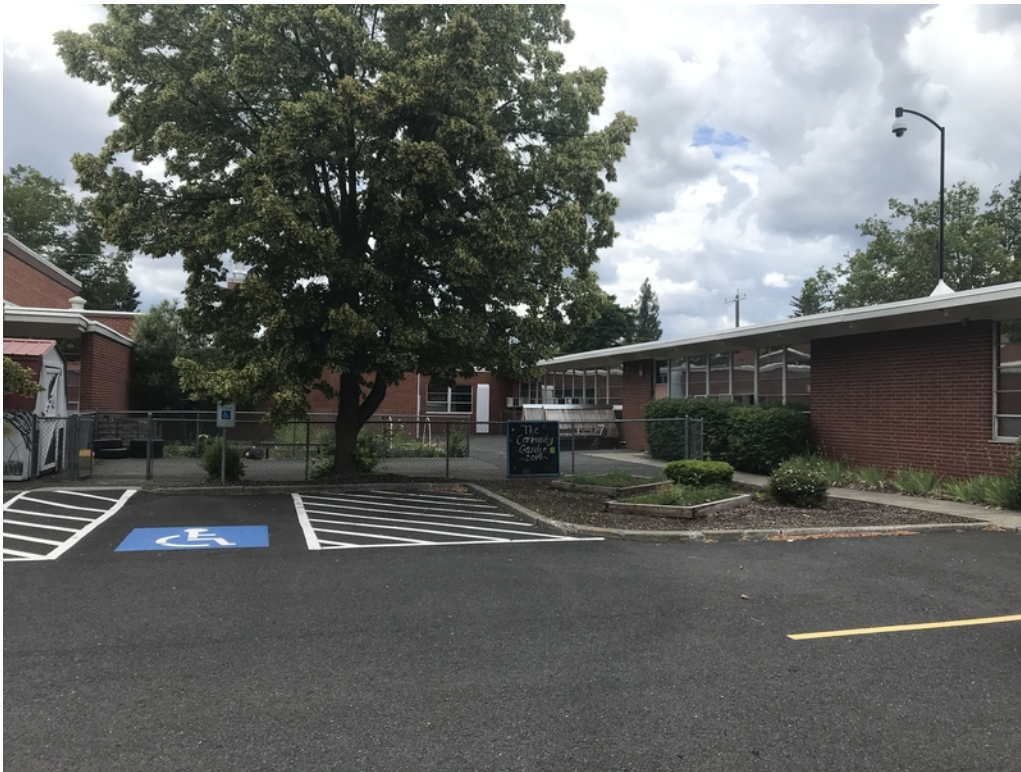
**Figure 1-5. South and east sides of the north and west wings, respectively.**

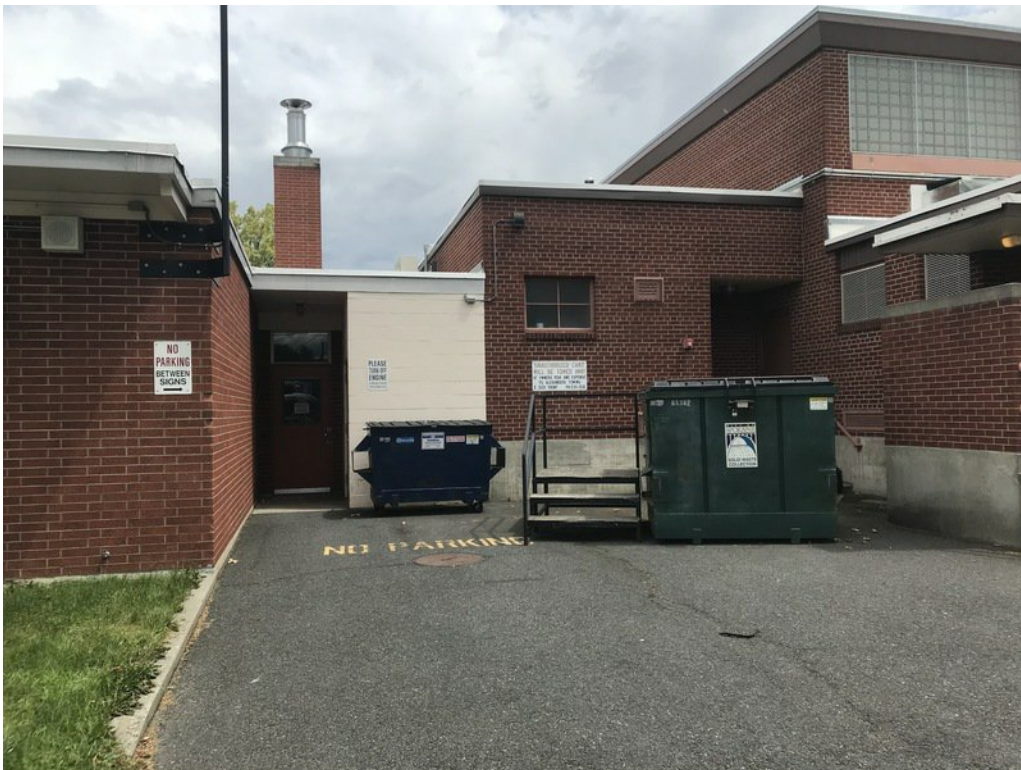
**Figure 1-8. West side of the building by the multipurpose room; masonry chimney observed to the north of the multipurpose room (most likely over the mechanical room).**

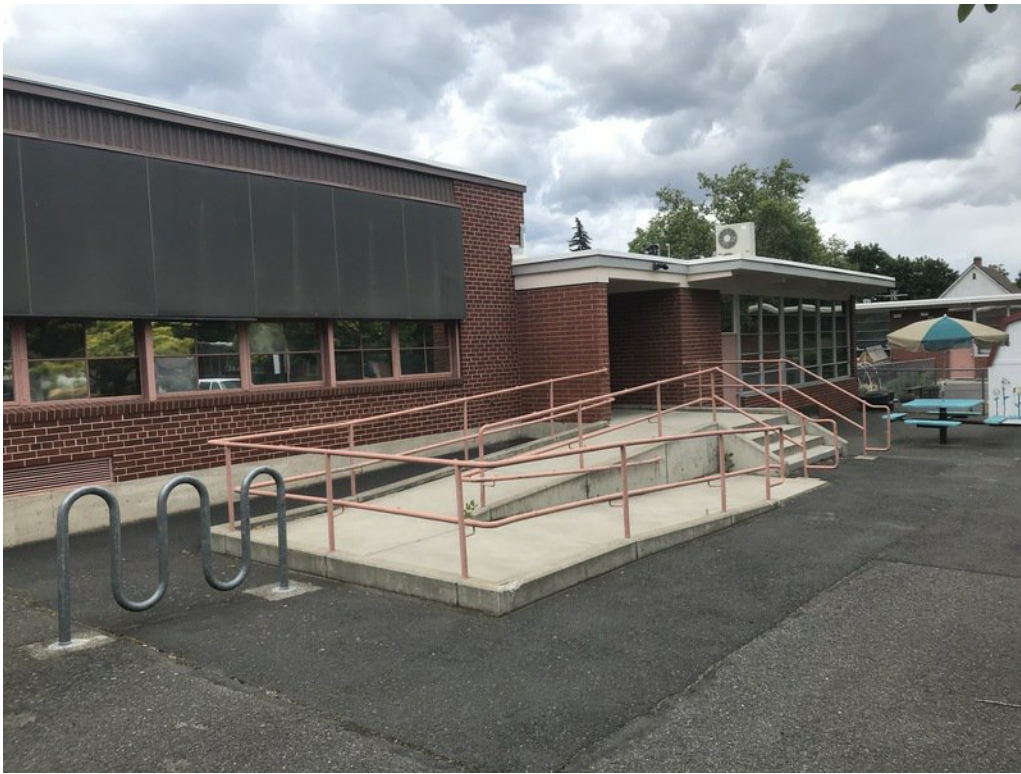
**Figure 1-9. Concrete ramp access on the south side of the building.**

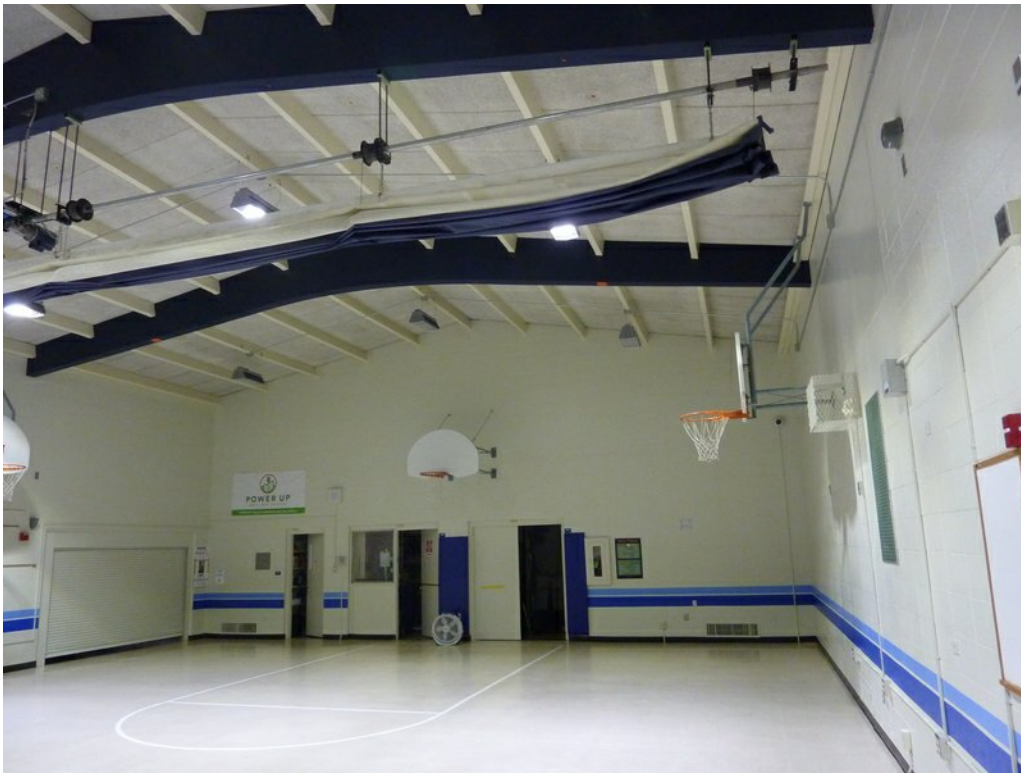
Figure 1-1. Gymnasium looking south with wood purlins and glulam beams visible.

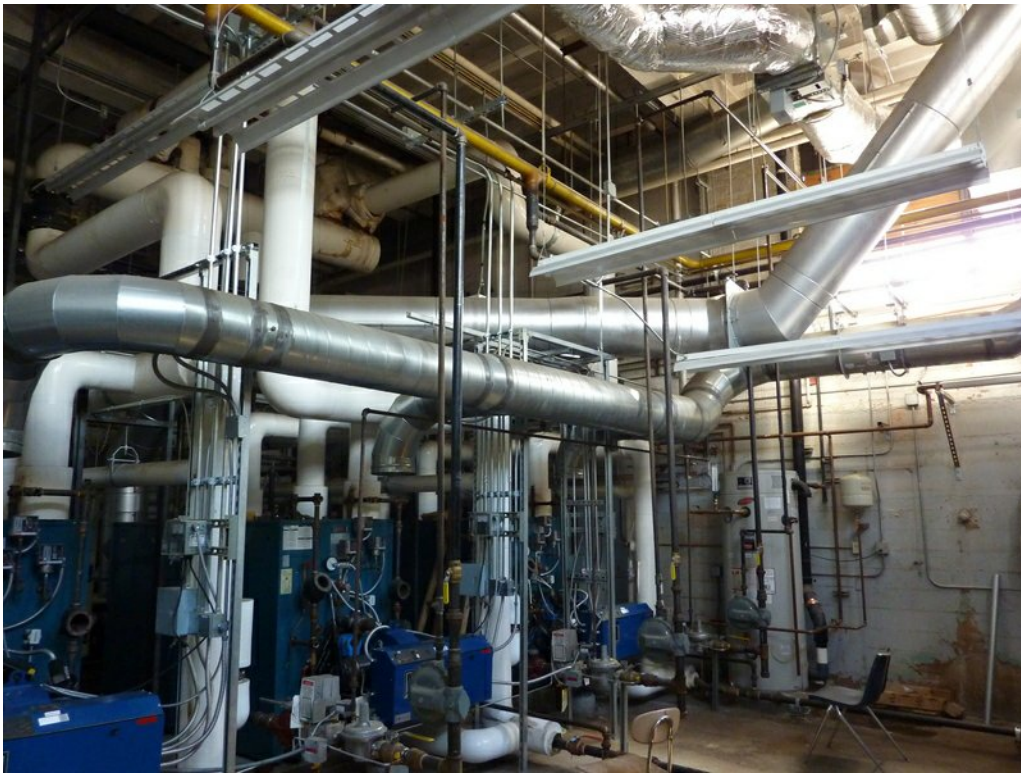
**Figure 1-1. Boiler room. Partially underground, no bracing on water tanks, no bracing on piping, gas shutoff valves at each piece of equipment.**

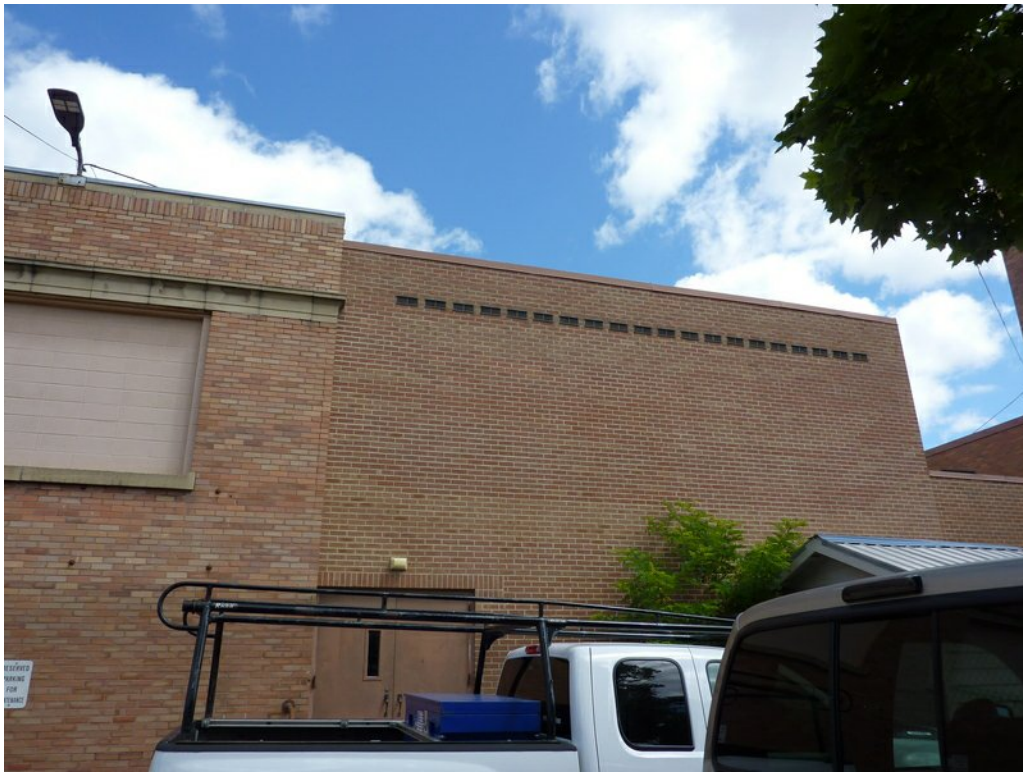
Figure 1-1. South elevation at joint between original 1928 portion of building to the left and 1960 addition to the right.

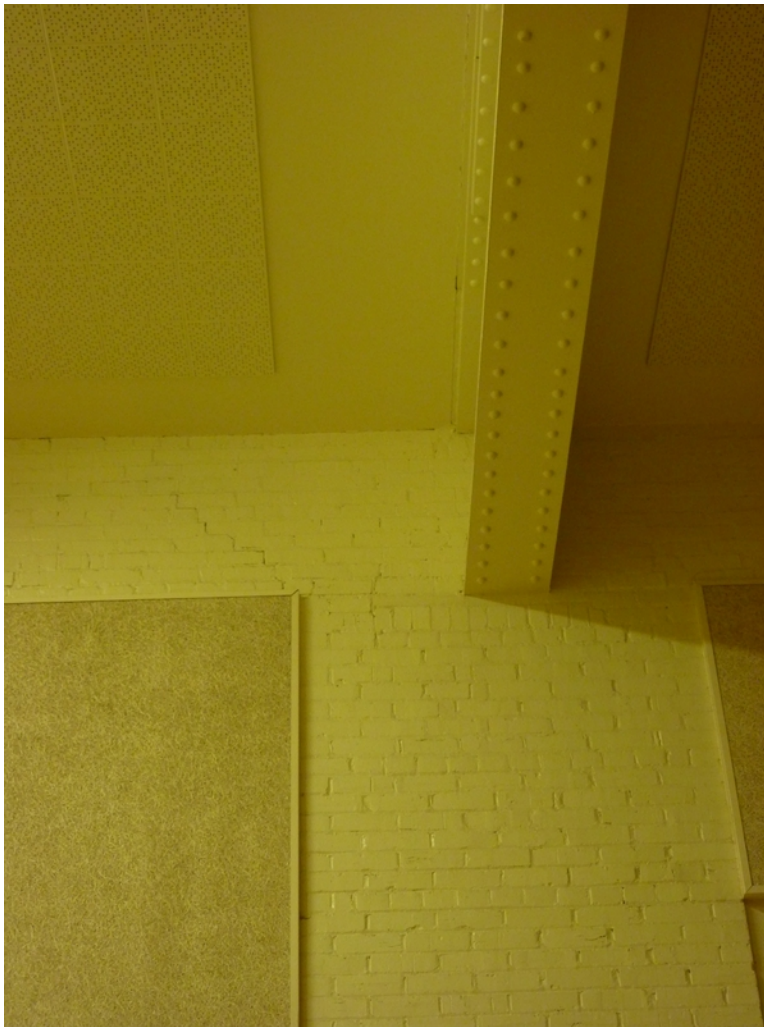
**Figure 1-3. Crack visible in exterior URM wall adjacent to girder bearing at corner of original opening that has been infilled.**

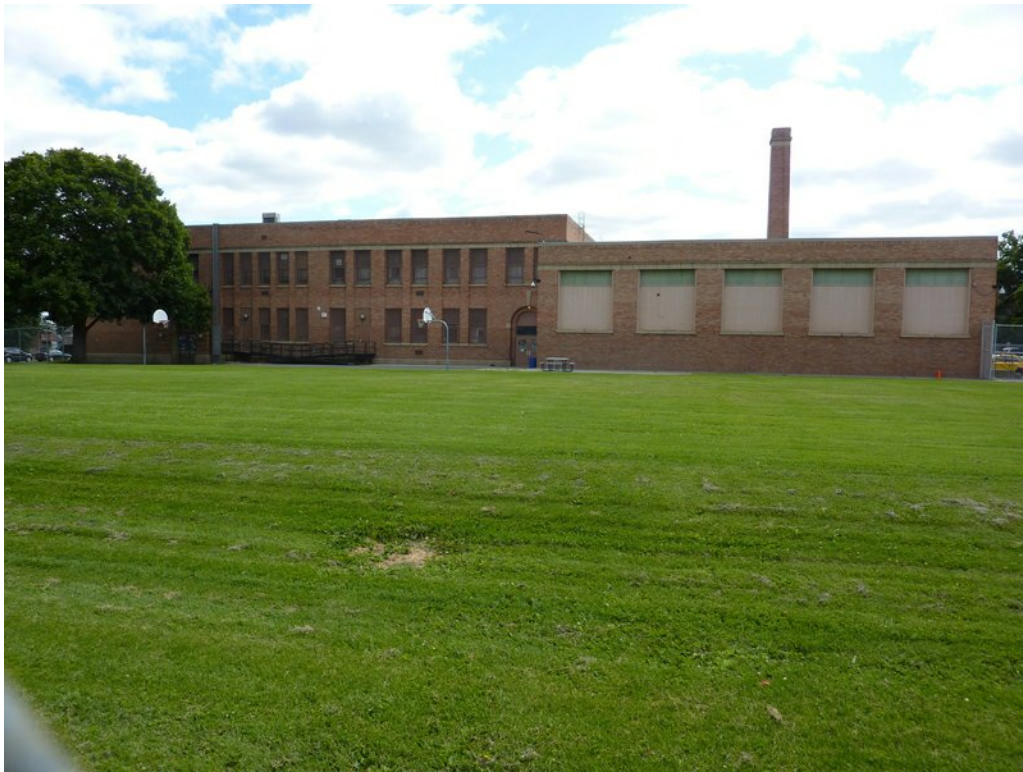
**Figure 1-4. West face of building with gym building to the right and the main school building to the left. The URM chimney above the boiler room of the main building can be seen beyond the gym building.**

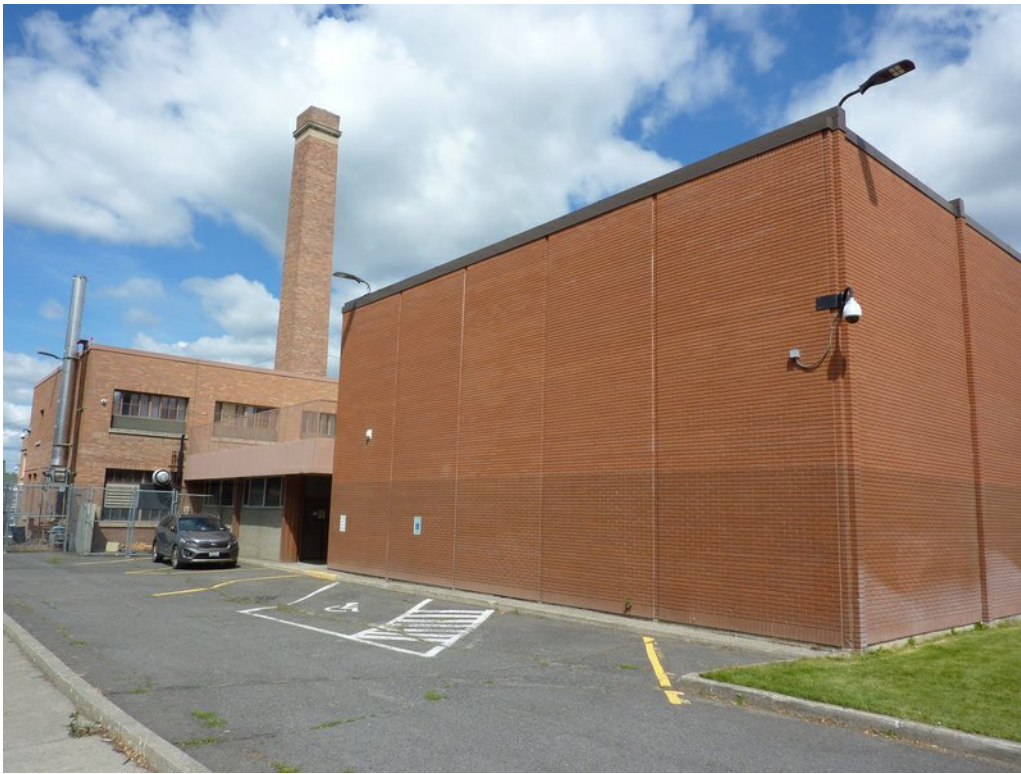
**Figure 1-1. View at southeast corner of building. A portion of the original 1928 building is seen in background .**

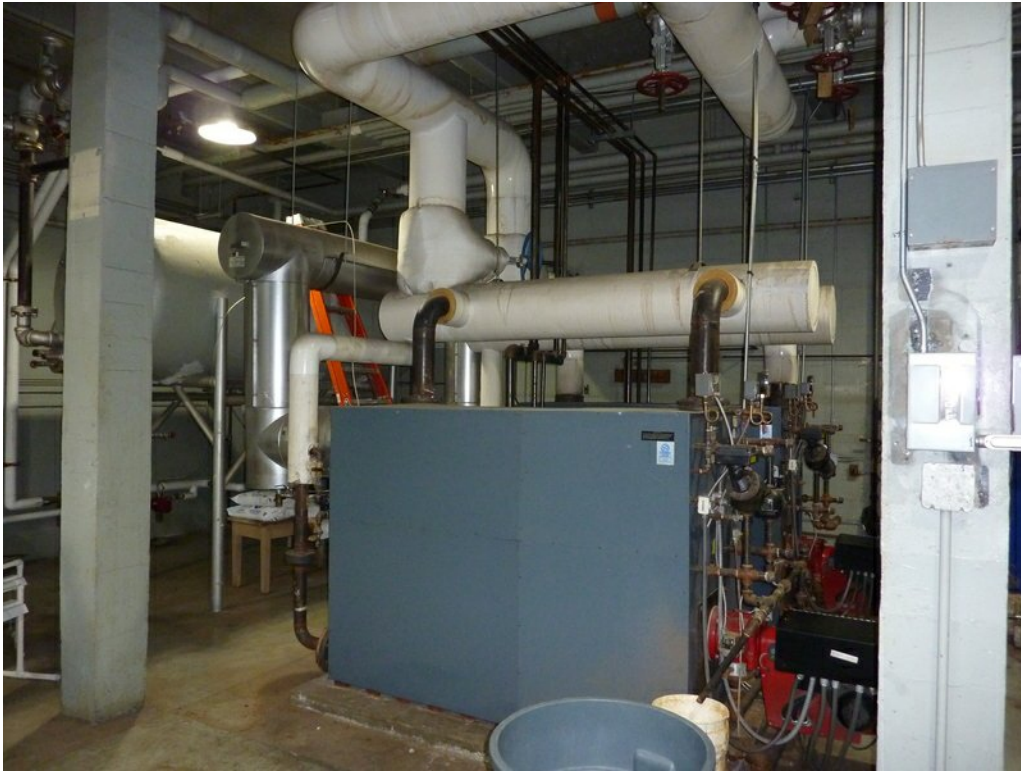
**Figure 1-1. Boiler room with no visible lateral braces on overhead piping, water heater not strapped to the wall (present, not visible). Gas shutoff at each unit.**

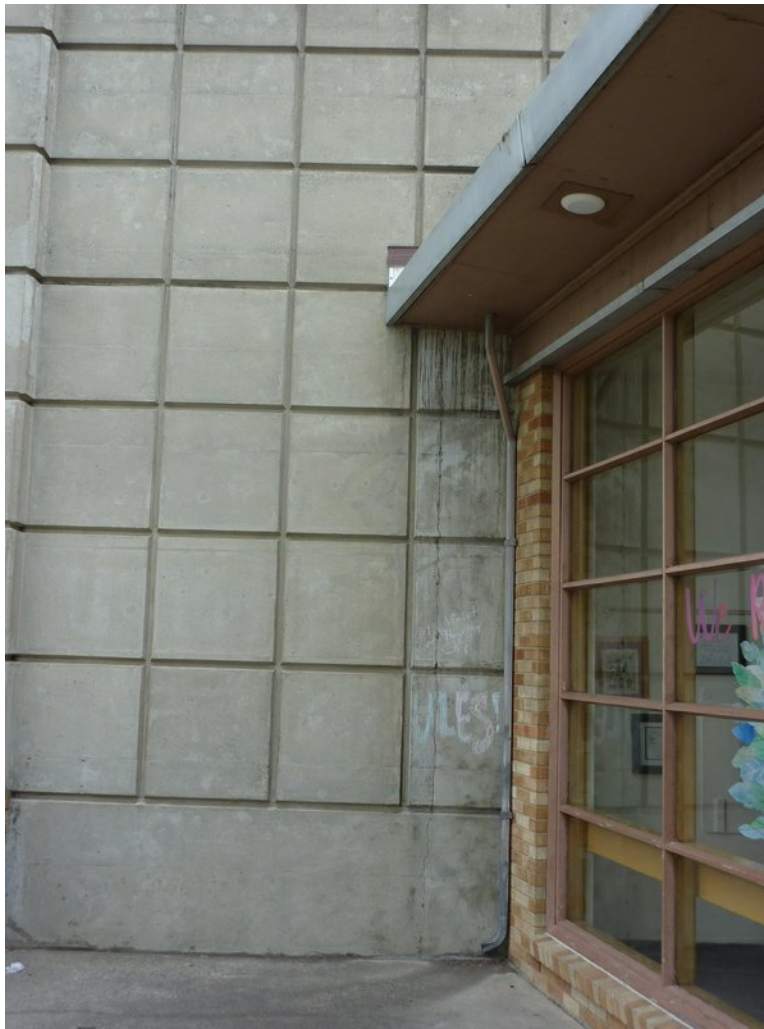
**Figure 1-10. Crack at entry concrete wall, relatively small in width.**
